Bulletin: CLIB-0001

Date: October 18, 2005

Bulletin Type: Service

Topic: Idle Rattle in Heavy Duty Trucks

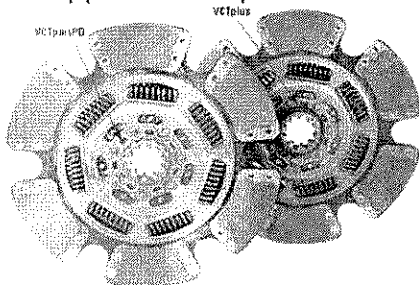
Eaton Clutch Division has developed the VCT Plus PD (pre-damper) clutch disc that has a special first stage in the damper, which is designed to isolate the engine idle pulsations before the pulsations reach the transmission. The pre-damper disc can be identified by the presence of 7 small springs around the hub.

- Raising the engine idle RPM will change the idle characteristics of the engine and the noise may diminish. The recommended maximum default idle speed is 750 RPM.
- Install the VCT Plus PD (pre-damper) clutch discs, which are available for applications up to 2250 lb-ft with the different Eaton 15.5" clutch models.
